# ROLLOVER EJECTION MITIGATION USING AN INFLATABLE TUBULAR STRUCTURE (ITS)<sup>†</sup>

Simula ASD, Incorporated

National Highway Traffic Safety Administration

Paper Number 98-S8-W-18

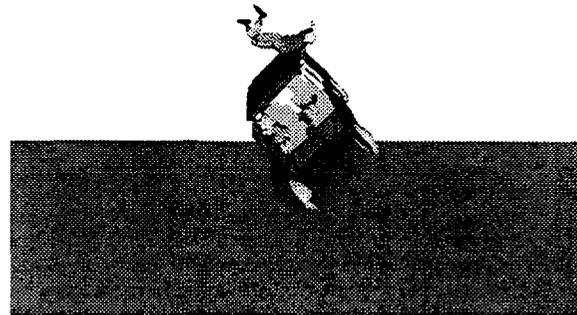
Figure 12 -- Driver Ejection during simulation of the first rollover test without an ITS

The baseline simulations were validated to reproduce the occupant kinematics measured in the two tests. When the ITS devices were removed, all four of the unbelted occupants in the first two tests were ejected.
